FINAL ARCHAEOLOGICAL RESOURCES REPORT 300 SPEAR STREET PROJECT SAN FRANCISCO, CALIFORNIA

**Final Archaeological Resources Report
300 Spear Street Project
San Francisco, California**

**Major Environmental Analysis,
Planning Department,
City and County of San Francisco**

September 2007

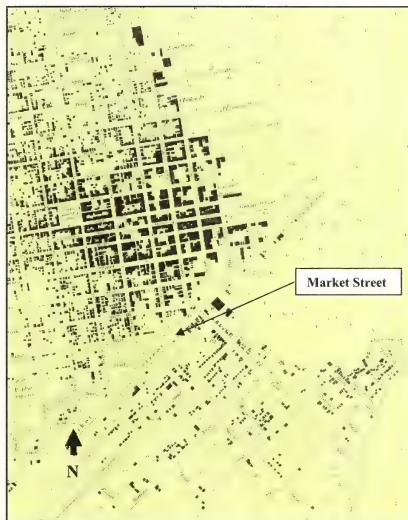
1853 U.S. Coast Survey Map showing maritime commerce concentrated on the north side of Yerba Buena Cove.

As depicted on the 1853 U.S. Coast Survey map, the maritime commerce of the city was concentrated on the northern side of the cove, north of Market Street and its projecting wharf. South of Market Street, undulating sand dunes – some in excess of 60-feet in height – defined the topography between the city's commercial district and the rocky formation of Rincon Hill.

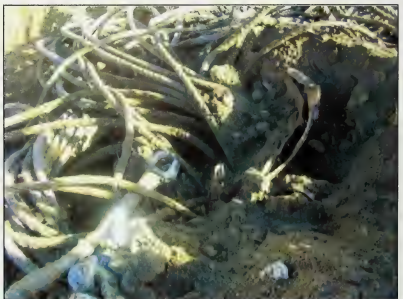
Three large, coiled, plaited steel cables were found in the western corner of the project area (Photo 3). Two of the cables measured 2-inches in diameter; one measured 1 1/4-inches in diameter. Each of the cables was over 50-feet in length, although

Photo 3. Coiled steel cables with spliced ends.

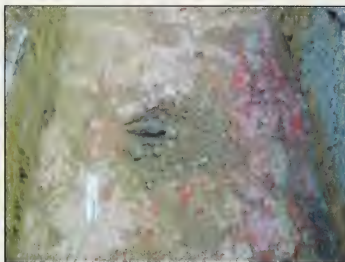
Trench 1 was 10-feet in length, 4-feet in width, and 4 1/2-feet in depth (refer to Figure 4). A brown sandy, relatively sterile fill was encountered in the upper layers of the excavation. A 6-inch thick slab of brick chunks held together by concrete mortar (dubbed "brickment" and designated as P1-Feature 20), was encountered 26-inches below the modern surface (Photo 7). Overlying the slab was a thin surficial layer of concrete (approximately 2-inches thick).

Photo 7. Brick pavement in Trench 1, view north.

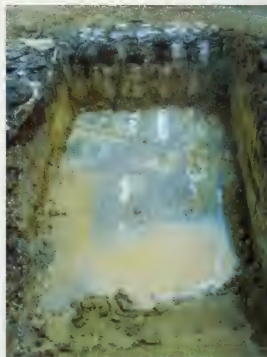
Trench 2 was placed immediately west of Auger 10 and south of Auger 23. Trench 2 was 10-feet in length, 4-feet in width, and 5-feet in depth. As in Trench 1, a brown sandy, relatively sterile fill was encountered in the upper layers of the excavation, immediately below the gravel base of the modern asphalt parking surface. Approximately 2-feet below the surface, a 5-inch thick concrete slab was encountered and designated as P1-Feature 21 (Photo 8). Sand-and-rock fill, 2-feet thick, containing a large quantity of historic material, primarily construction material such as brick and wood fragments, lay below the concrete slab. No diagnostic artifacts were recovered from this stratum. Below this was a layer of sand and clay with very few historic artifacts. The layer was of indeterminate depth, but probably represents the cove fill. No diagnostic artifacts were recovered from it, and no other human remains were discovered.

Photo 8. Concrete slab in Trench 2, view north.

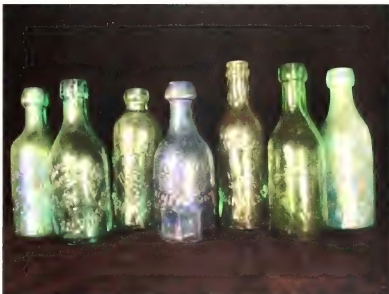
Photo 11. Bottles with identifying marks.

In contrast to the early B&G bottle is a later example of the Pioneer Soda Water bottle, produced between 1897 and 1906. It is made of clear greenish aqua glass with a tooled finish. Prior to 1897, the company was known as the Pioneer Soda Water Works, with proprietors Martin Walsh and Charles Welch. In 1897, the company changed its name to the Pioneer Soda Water Co. It was located at 1555 Mission, with William Welch and George W. Collins proprietors (Markota and Markota 1971:80). Additional local soda water companies were also represented in the collection, including Classen & Co.'s Pacific Soda Works, Classen & Co.'s Sparkling Cider, Empire Soda Works, American Soda Works, Jackson's Napa Soda Springs, and C.A. Reiners & Co. Along with the local distributors, East Coast companies such as Seitz and Bros. are also represented in the collection.

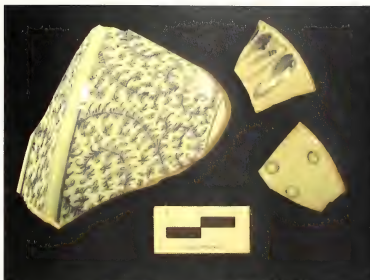
Photo 13. Chinese ceramic sherds.

In addition, two fragments of Chinese stoneware (likely from a rice bowl) with blue/gray decoration in the 'Three Circles and Longevity' pattern were collected (Photo 13). A single sherd from a larger vessel was also recovered. Its blue vine decoration was applied over a blue/green glaze.

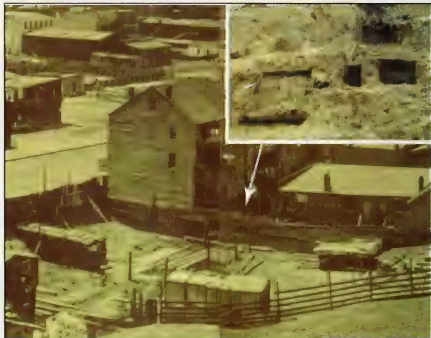
Photo 18. Approximate location of P2-Feature 9 (inset), seen in the 1872 Muybridge Panorama.

Two additional wood structures (P2-Features 9 and 19) encountered during excavations in the southwest portion of the project area were also likely associated with the lumberyard (Photo 18).

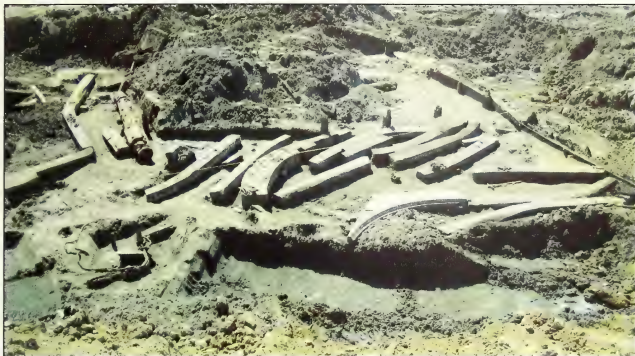
Photo 19. P2-Feature 15, view south.

P2-Feature 15, located in the south-central portion of the project area, consisted of structural remnants and scattered ship timbers and ship-related materials associated with Charles Hare's ship breaking operations (Photo 19; Figure 22). It is likely that

components of this feature were deposited between 1851 and 1857, the period in which Hare operated his yard.

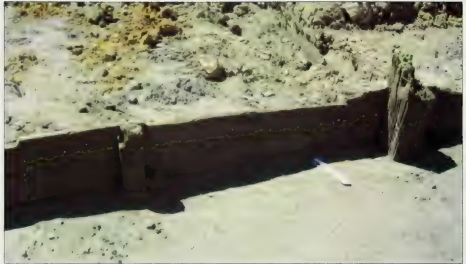
Photo 20. Short board wall located in P2-Feature 15.

The feature's southern boundary was delineated by a 15-inch tall, 48-foot long wood wall that was oriented northwest (305 degrees) to southeast (120 degrees) (Photo 20). The southwest portion of the short wood wall was well preserved, and intact support stakes were visible along the north side of the wall. The northwest portion of the wall, along with its support stakes, was folded over and cracked. The northwest terminus of the wall formed a right-angle and an additional section of wall extended to the southwest (216 degrees) approximately 18-feet, where the remainder of the wall had rotted away. However, a line of support stakes was still visible, extending to the southwest a distance of 5 or 6-feet, indicating that the short board wall had continued in that direction.

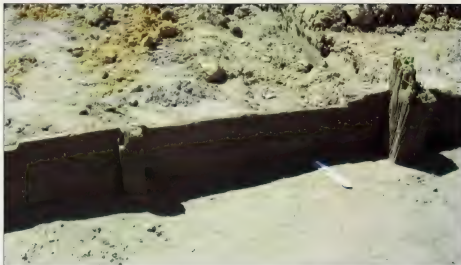
Photo 20. Short board wall located in P2-Feature 15.

The feature's southern boundary was delineated by a 15-inch tall, 48-foot long wood wall that was oriented northwest (305 degrees) to southeast (120 degrees) (Photo 20). The southwest portion of the short wood wall was well preserved, and intact support stakes were visible along the north side of the wall. The northwest portion of the wall, along with its support stakes, was folded over and cracked. The northwest terminus of the wall formed a right-angle and an additional section of wall extended to the southwest (216 degrees) approximately 18-feet, where the remainder of the wall had rotted away. However, a line of support stakes was still visible, extending to the southwest a distance of 5 or 6-feet, indicating that the short board wall had continued in that direction.

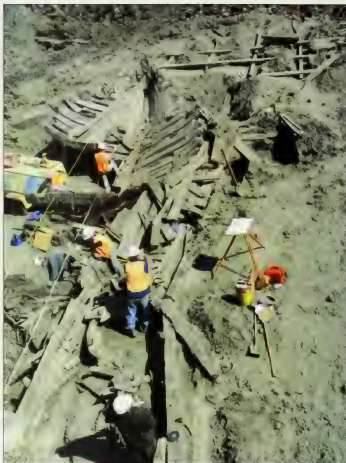
The rudder was intact and measured 73-inches in length (from top to bottom), 25-inches in width at its narrowest (at the top), 38-inches at its widest (at the bottom where it flared out), and 7-inches in thickness (refer to Figure 29). Wood sacrificial planking⁵, 3/4-inch thick, encased the entire rudder. This was covered with copper sheathing. The sacrificial planking and copper sheathing had peeled away from the rear edge of the rudder, revealing a 2-inch diameter bronze bolt head, suggesting that the rudder was constructed of two or more timbers bolted together. Black pitch, used to

Photo 21. P2-Feature 16, view east.

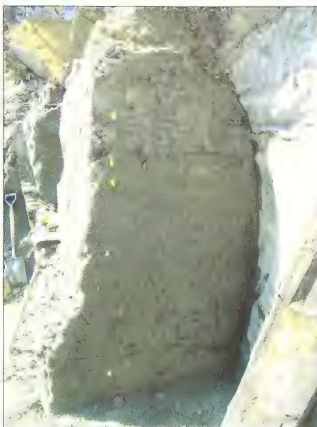
Photo 22. Soil profile observed in sediment block along port side of stern. Yellow tags indicate differing soil layers.

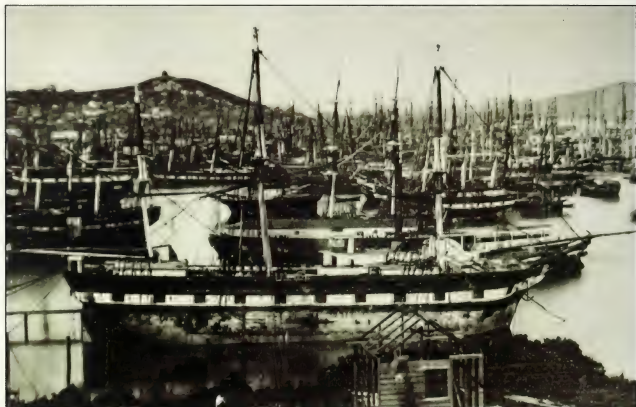
This ca. 300 ton barque is moored at or adjacent to Hare's breaking yard, near today's intersection of Spear and Folsom streets. The barque lies off the Folsom Street alignment; the line of capped pilings visible behind its stern is the property line of the waterlot. They outline the southern boundary of Folsom while the vessel lies across the Spear street alignment. Although this 1853 photo predates the arrival of the *Candace*, the barque pictured is of similar size and appearance. (San Francisco Maritime National Historical Park, J. Porter Shaw Library, A11.4528-c.)

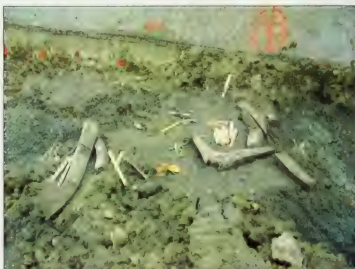
P2-Feature 18 encompasses a portion of Hare's ship breaking yard that was located in the northeast corner of the project area near Spear Street (Figure 32, Photo 23). Ten ship timbers were found in an area that measured 28 feet north-south by 27 feet east-west (refer to Figure 32). The feature was located 28 feet below the site datum.

Photo 23. P2-Feature 18, view northeast.

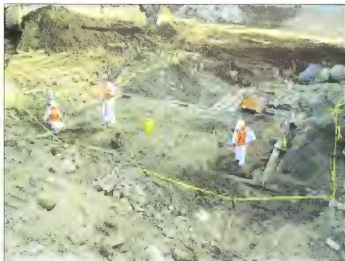
P2-Feature 8 consisted of a rectangular wood foundation, measuring 20-x-25 feet, and associated historic debris (Figure 33, Photo 24). The feature was located in the south-central portion of the parcel. The GIS plot for P2-Feature 8 overlies the footprint of a rectangular-shaped structure depicted on the 1859 U.S. Coast Survey map. If P2-Feature 8 represents the foundation

Photo 24. P2-Feature 8, view north.

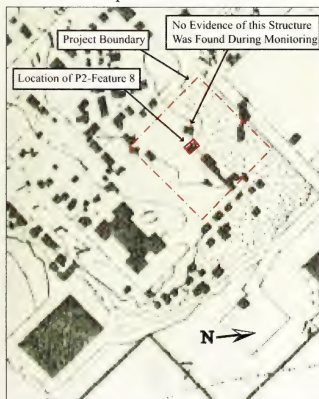
Location of P2-Feature 8, as seen on the 1859 U.S. Coast and Geodetic Survey Map.

of this structure, it was likely constructed some time before 1859, shortly after the filling of Yerba Buena Cove.

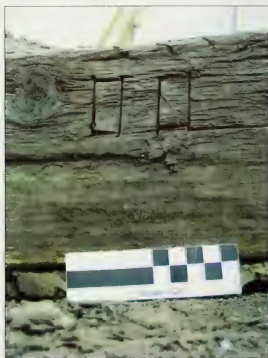
Photo 27. Carpenters' marks on end of foundation beam.

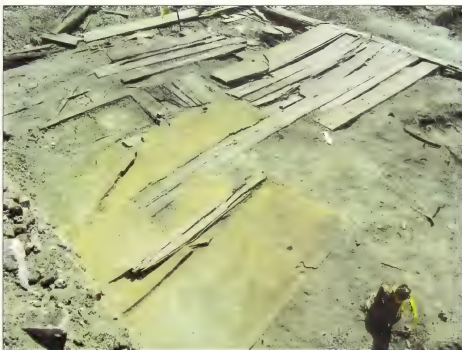
Photo 28. Wood and metal debris located adjacent to the east side of the wood foundation in P2-Feature 8, view south.

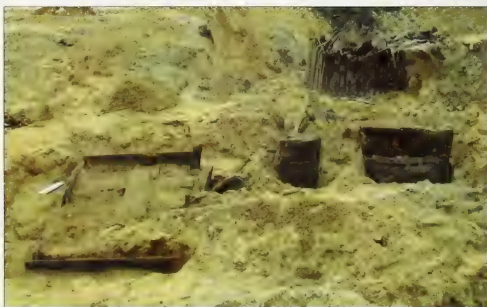
Photo 29. P2 Feature 9, view west.

Structure A was the most northern structure in Feature 9 (refer to Figure 34). The 40-x-49-x-5 inch rectangular redwood structure was constructed with vertically placed wood planks and was irregularly shaped, with its long sides measuring 47 and 51-inches, respectively, and its shorter ends measuring 39 and 40-inches respectively. The planks ranged from 9-to-16 inches in width and were 3/4-inch thick. The base was deeply embedded in the sand, suggesting that sand had been originally built up around the sides of the structure. Because the top of the structure had been destroyed, the original height of the structure could not be determined; the excavated remains of the structure were approximately 2 1/2-feet in height.

A variety of historic debris was recovered from within the structure, including faunal bone, coffee beans, fruit pits and seeds, bottles, buttons, ceramic, children's shoes, a metal wheel, and a hair comb.

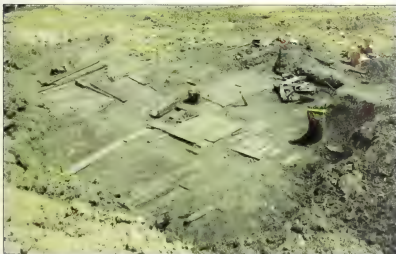
Photo 30. P2-Feature 13, view northeast.

Feature P2 Feature 13, seen intact in the 1872 Muybridge Panorama (refer to Figure 9: View 1), consisted of a complex of wood structures that included portions of a toppled fence, a plank walkway, and an associated wood structure that tentatively is interpreted as

a wood-lined privy. These structures were situated in the southern portion of the project area (Figure 35; Photo 30), and located 15-feet below the site datum. The feature components were concentrated in an area that measured approximately 28-feet northeast to southwest by 27-feet northwest to southeast. Just outside this area, to the south, a few randomly placed boards were

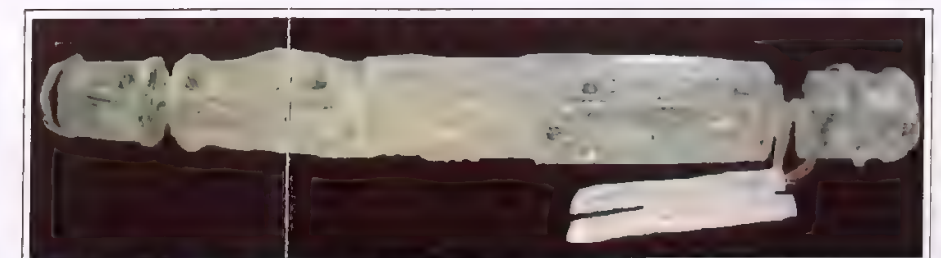
P2-Feature 15
W-1: Windlass
2 of 2

- Treenail 7/8" diam.
- Treenail hole 7/8" diam.
- ◊ Drift bolt 3/4" diam.
- ◊ Drift bolt? hole 3/4" diam.
- Corroded metal
- MC Metal concretion
- ~ Decayed / damaged area

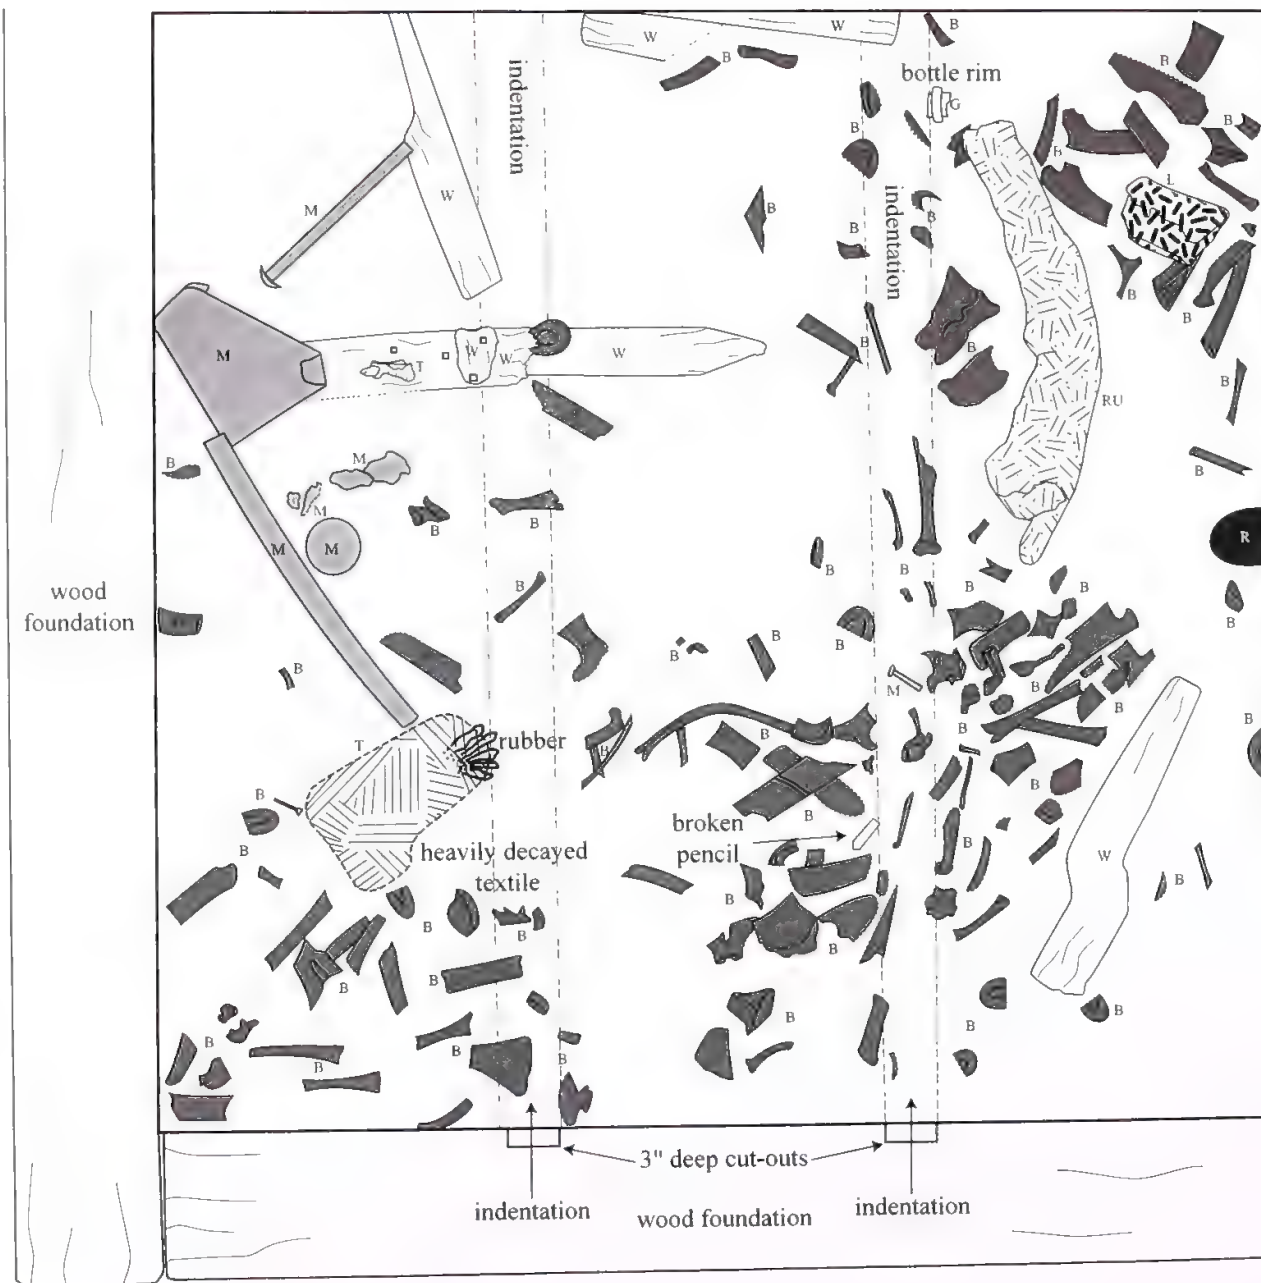
Figure 33a

Plan View

North-East Wall Profile

- Culturally sterile - gley 5G 4/2, grayish green, heavily compact rocky clay
 - Cultural deposit - 10YR 3/1, very dark gray, moderately compact charcoal rich clayey silt
 - Culturally sterile - 2.5Y 4/3, olive brown, moderately compact sand
- NB. Soil stain in base of two indents in sand layer are 2.5Y 3/1, very dark gray

The sediments of this second layer transitioned quickly to a culturally sterile, moderately compact native sand (Munsell: 25Y 4/3), which was located under the cultural layer, approximately 12-inches below the unit datum. Linear indentations indicating the presence (and removal) of floor joists were observed on top of the sandy substratum (refer to Photo 26). Staining from the floor joists was still visible at the bottom of the sandy indentations, indicating the wood had been in direct contact with the sand (Munsell: 25Y 3/1).

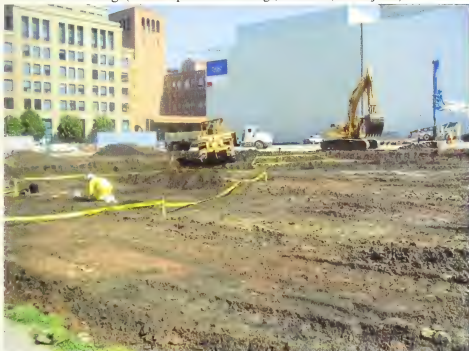
P5. Photo or Drawing (Photo required for buildings, structures, and objects.)

View NE, 04/01/2005
